Place of Inspection: Marlborough Court 28 Marlborough
Road Chingford E4 9AL
Date: 22/02/2025
Inspector: Michael Thirkettle
Time: 09:30
Report Created: 28/02/2025

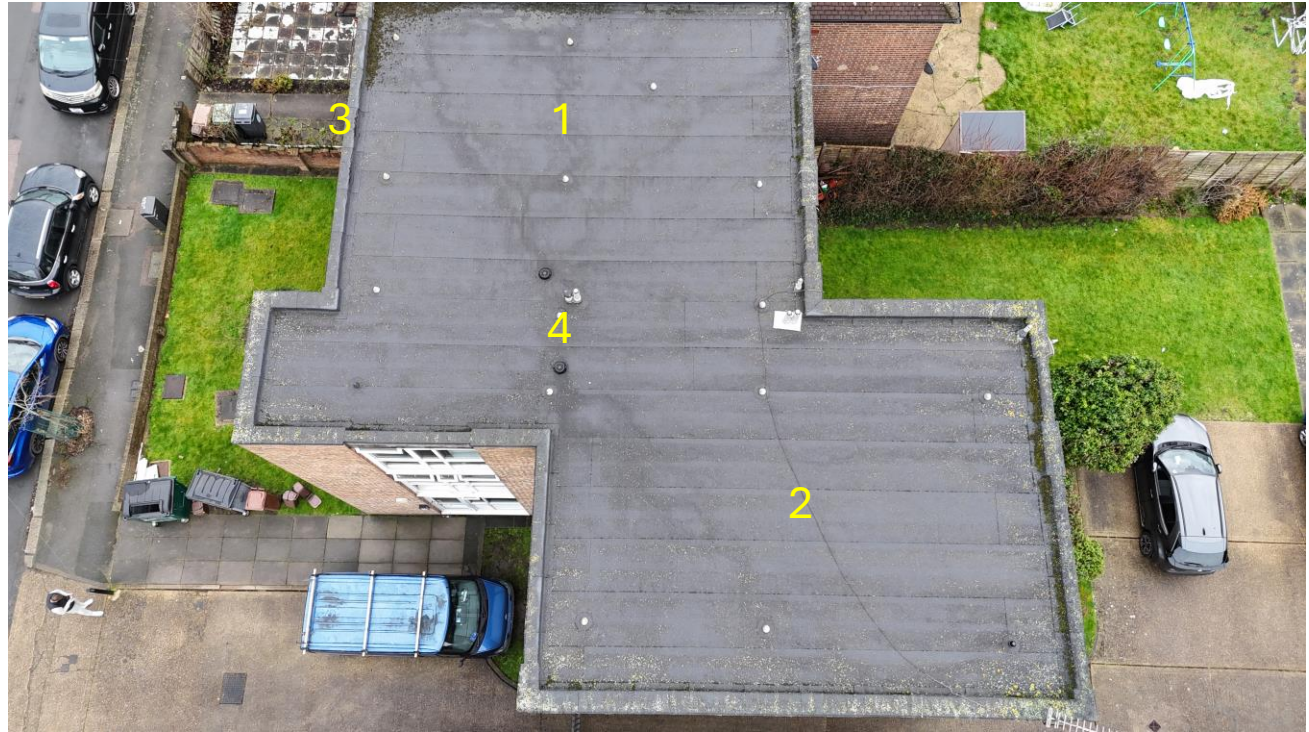
Flat roof - 1

No current issues found

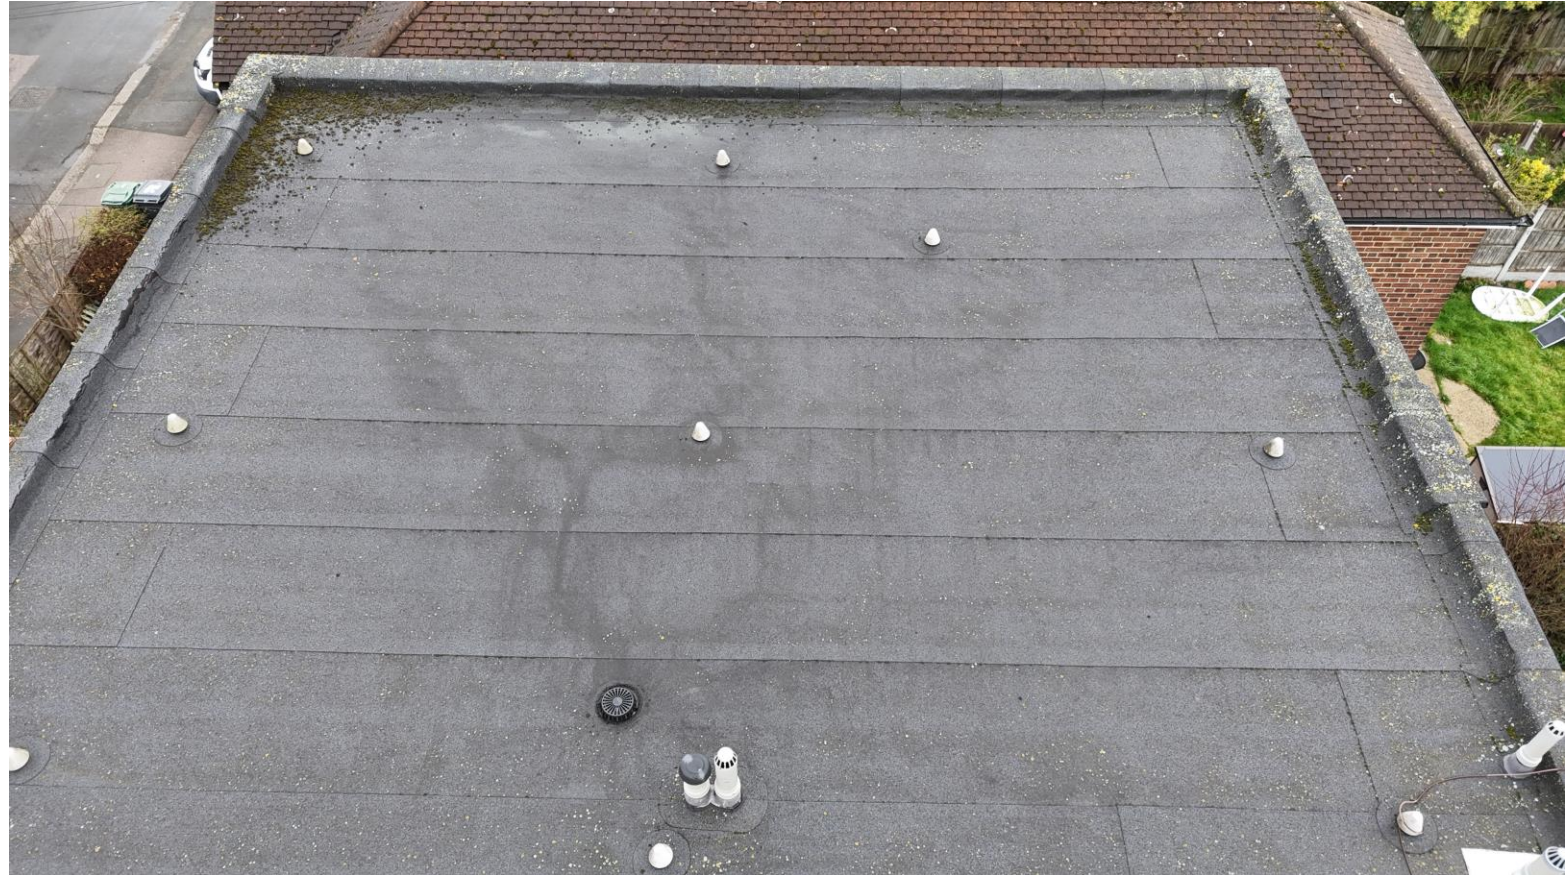
Flat roof - 2

No current issues found

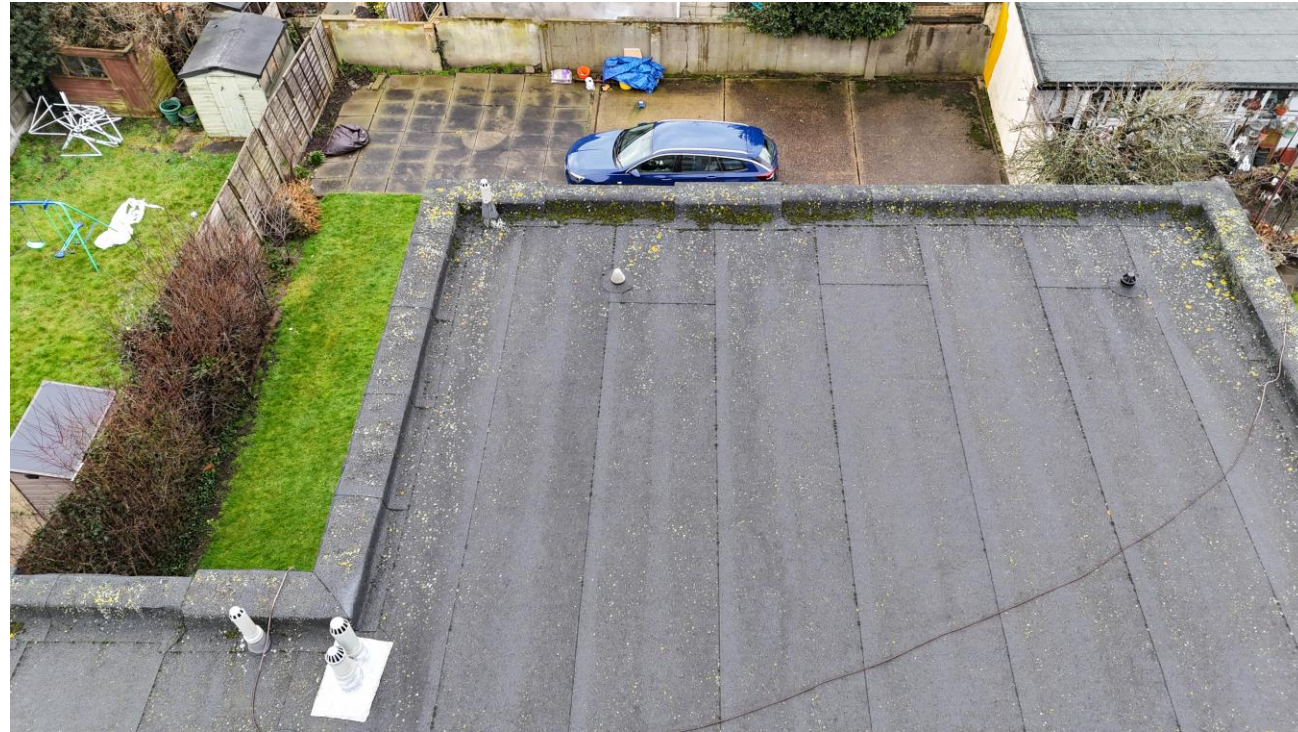
Chipping - 3

Large gaps missing in the minerals.
From inspection looks larger than
last year but still bonded. More
splits have developed also

Complete the repair work before a
potential split in bonding causes a
potential leak.
