Place of Inspection: Marlborough Court 28 Marlborough
Road Chingford E4 9AL
Date: 22/02/2025
Inspector: Michael Thirkettle
Time: 09:30
Report Created: 28/02/2025

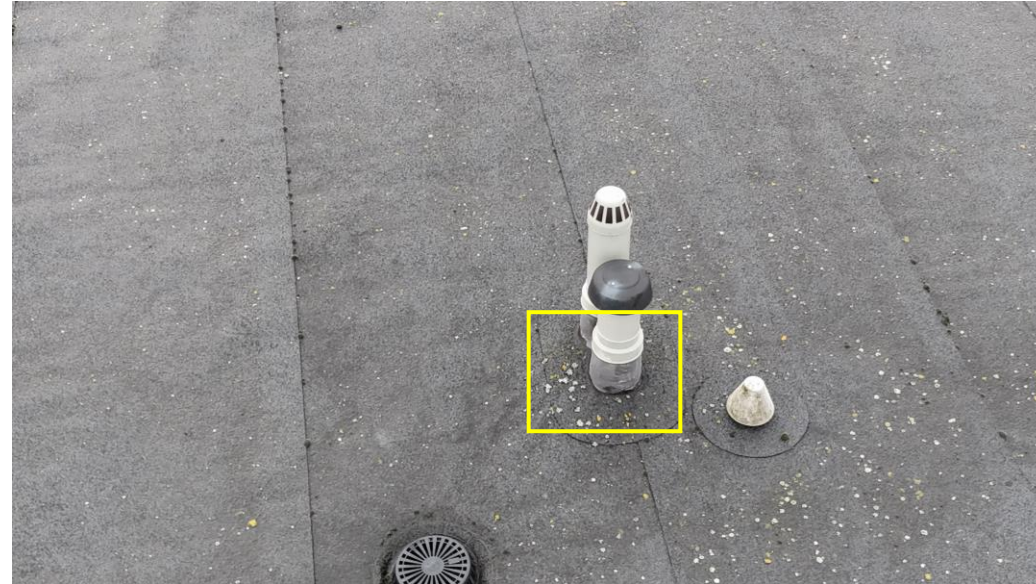
Pipe Sealant - 4

Issue:

As identified on last years report sealant can be seen to be breaking away

Recommendation:

Reseal pipe before it becomes an issue
